Heat resistant alloys: Selection and failure avoidance

Jason Wilson, Devin Wachowiak (Rolled Alloys USA), Stephen Pollard (Rolled Alloys UK), and Alex Huang (Rolled Alloys China)

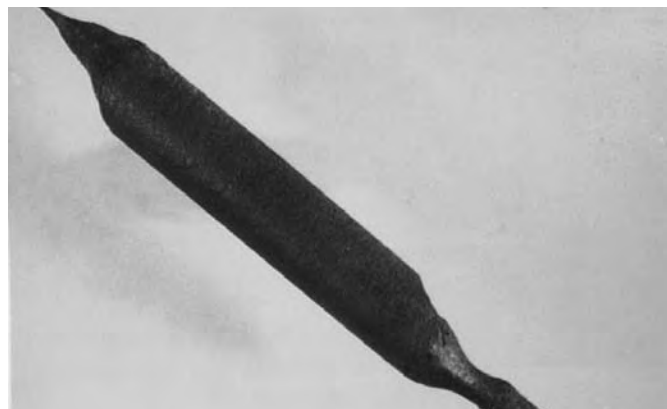
316L round bar 3/4 inch in diameter exposed to 1800°F (982°C). Air atmosphere. 316L is suggested to be used only to 1500°F (816°C), due to scaling. In contrast its melting point is 2540°F (1343°C).

oxidation limits several hundred degrees below their melting points. Heat resistant alloys depend on the formation of an adherent protective oxide scale. This protective oxide scale is primarily formed by chromium in the alloy; however, they can be enhanced by silicon, aluminum and rare earth additions. At the suggested maximum temperature for each alloy, the oxide flakes off of the surface too rapidly and metal wastage will occur.

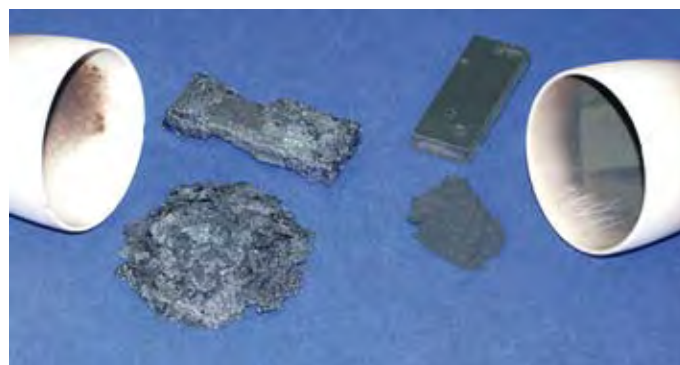
View of alloy 600 (left) and alloy 602CA (right) samples after 3000 hours at 2150°F (1177°C). Both samples began as 1/4" (6.3 mm) plate.

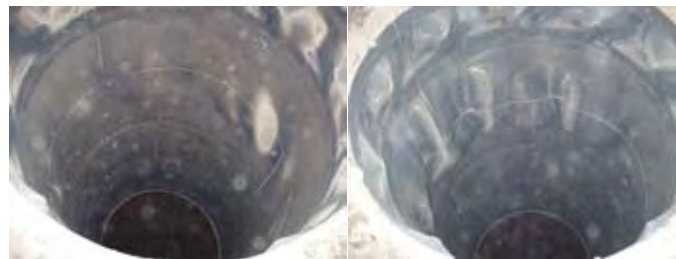
253MA replaced type 310 stainless in this fluidized bed cyclone dip tube. That measures 8.5 ft (2.6 m) diameter and 23 feet (7 m) long and operates at 1600°F (871°C). 253MA lasts at least 6 years before distortion shown at right led to its replacement. 310 stainless required replacement every 2-3 years.

Photos in this article show two operations where 253MA has successfully been substituted in place of 309, 310, and RA330.

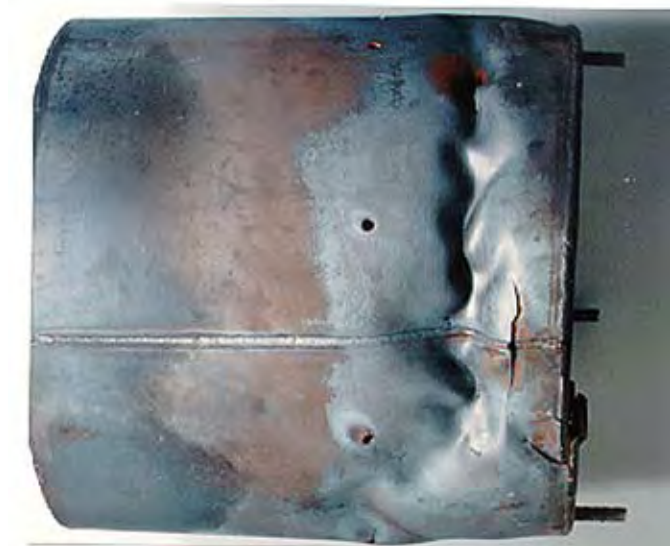
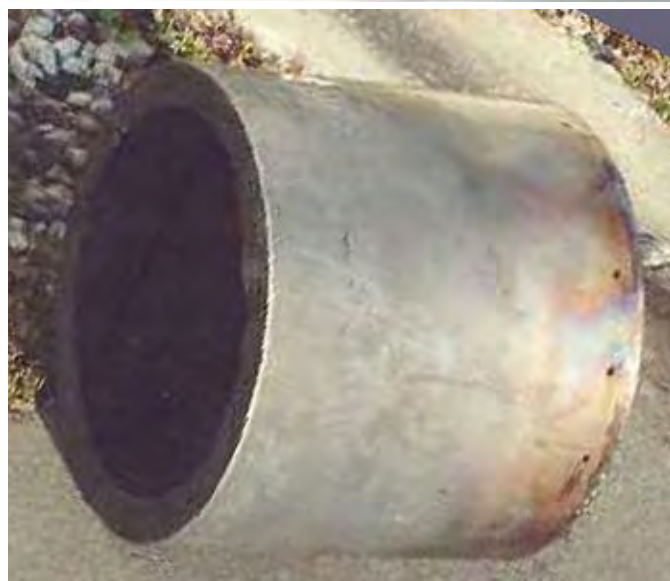
This burner can made of 3mm (11ga) 253MA is a good example of what can happen when uneven heating occurs. In this case above, flame impingement occurred during a low fire condition. The photo below shows a can after use with a good temperature profile under normal operating conditions. Gas flow is right to left.

The burner can shown in Figure 8 shows what can occur with uneven heating. During low fire the burner flame impinged on the walls of the burner can. The shiny glazed scale where the can has distorted indicates high heat exposure. The other areas of the burner can operated at much lower temperatures. The area with flame impingement was restrained from expanding by the cooler areas of the can. These cooler areas are also stronger because of their lower temperature. As a result, the area of flame impingement collapsed.

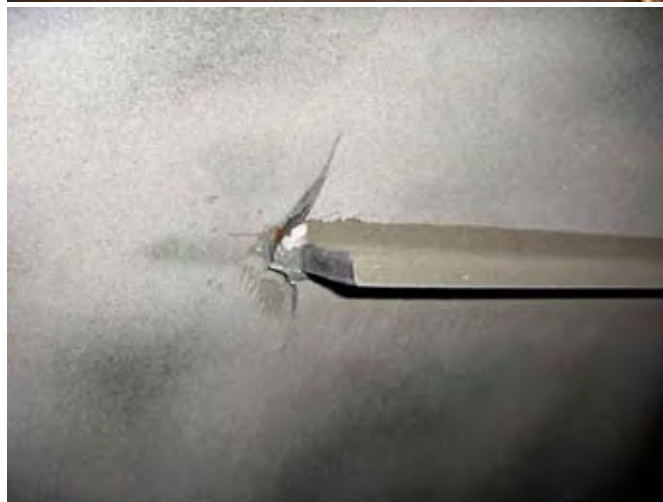
Calciner shell fabricated from 3/8 inch (9.5 mm) plate that suffered cracking. This was a result of temperature differentials between the shell and internal flights.

A calciner shell suffered cracking that occurred in a definite pattern (see photo). These cracks were found to occur at the ends of each internal flight (see photo). The cause of this cracking was temperature differentials between the shell and the flights. Gas-fired burners externally heated the calciner. The flights on the other hand were heated by energy conducted through the shell and were cooled by their more direct contact with the powders being processed. As a result, the flights operated at a lower temperature than the shell. As the hotter weaker shell tried to expand the cooler stronger flights restrained it. This resulted in the shell cracking under the stress at the ends of the flights. In this case, the suggestion was to refrain from solidly welding the flights. Instead weld the flights to the shell only at the center, leaving the ends free to expand or contract free of the shell.
