# Analyzing Belt Pin Failures

Integral components of furnace link belts, belt pins fail by distortion and fatigue. Apparent causes of premature failure include annealing and grain size variations.

By BRUCE McLEOD

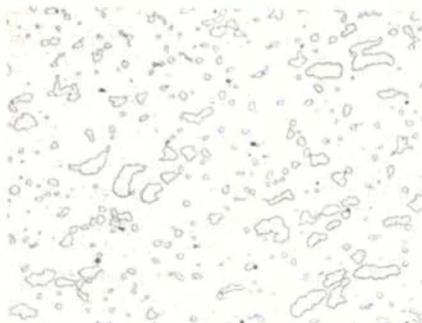
Fig. 1 — This belt pin, of RA 330-HC, became severely distorted during a year's service in a stress relieving operation at about 1,650 F under a loading of approximately 16 lb per sq ft. Micro (250X) shows massive carbides; compare with Fig. 2.

Figure 1 illustrates an example of crankshafting. In this particular in-

stance, a pin ( $\frac{3}{4}$  in. in diameter by 18 in. long) of RA 330-HC was used to pin a 60 ft belt operating with a load of about 16 lb per sq ft at approximately 1,650 F. This belt was in service for a year when severe crankshafting was observed.

When the belt was removed, observers noted that a considerable difference in the degree of crankshafting existed between various pins (Fig. 1 and 2). Also, pins having the most severe crankshafting were located at random throughout the belt. Because no pins had been replaced during the service life, there was every reason to believe that all pins had been subjected to the same service conditions.

Microstructural examination, however, revealed considerable difference in carbide distribution between pins. A pin with little crankshafting contained many fine dispersed carbides (Fig. 2), while a severely crankshafted pin had fewer, but more massive carbides (Fig. 1).

It is believed that the greater preponderance of finer carbides indicated a higher annealing temperature. More carbon was taken into solution at this higher temperature, resulting in greater carbide precipitation and consequent strengthening at operating temperatures.

The improved annealing process (heating at 2,150 F and water quenching) reduced failures due to crankshafting of belt pins. Ultimate failure, of course, may still be due to this cause if shear stresses are sufficient.

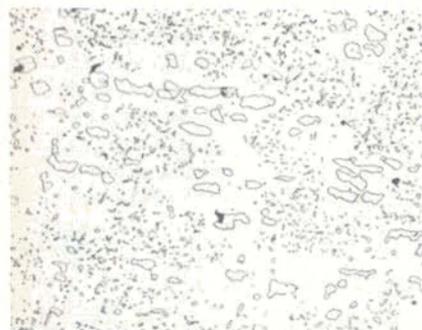
Fig. 2 — Though representing the same heat of material in the same application as the pin of Fig. 1, this pin was only slightly deformed ("crankshafted") after the same year of service. The cause is attributed to a different annealing cycle — unlike the pin of Fig. 1, this pin had fine, well dispersed carbides, shown at 250X in the micro.

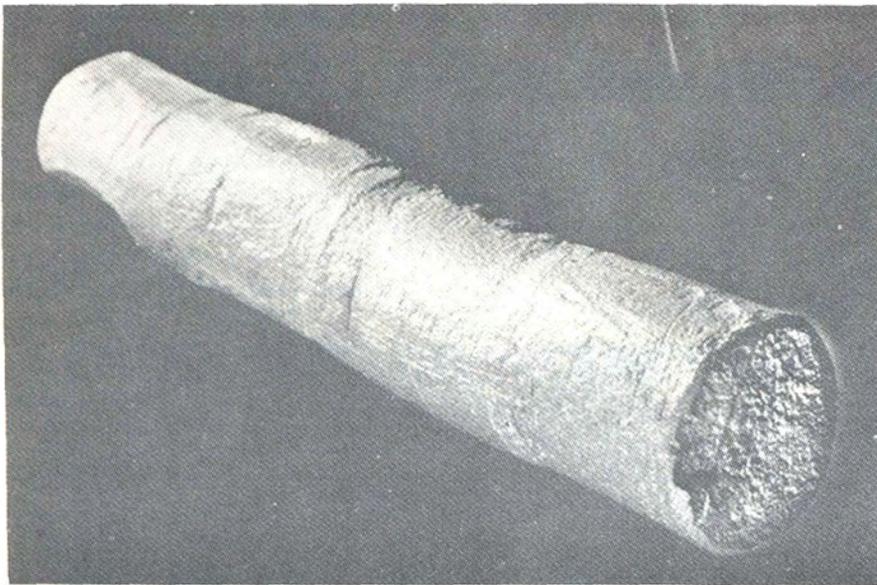
Fig. 3—This belt pin apparently failed because of mechanical fatigue. Note crack midway along the bar. This pin was cleaned by pickling.

While most belt pins fail because of distortion, some failures occur from mechanical fatigue (Fig. 3). During a complete cycle, a belt will reach the operating temperature of the furnace, pass over the drive drum at the discharge end (which is almost always driven by teeth), return under or through the furnace, and finally pass over the idler drum to repeat the cycle.

As the belt begins to engage either drum, torsional forces may be exerted on the pin as all links in the same line turn to meet the confining contour of the drum. These links then become stressed in the opposite direction after the links have rotated 180°, and the belt leaves the drum to begin its return. The catenary of the belt on the return flight also affects stresses that may be exerted on belt pins. Bending stresses can be imposed on the pins if skid rails are used to support the belt as it passes through the top (or work) flight of the cycle.

With successive cycles, these torsional and bending stresses rise and fall, making the furnace, in effect, a slow-cycle mechanical-fatigue machine for the belt pins. These nominal stresses are magnified greatly by mechanical problems, such as misalignment or crankshafting.
