Understanding Conditions that Affect Performance of Heat Resisting Alloys

By JAMES KELLY, Director of Technology
Rolled Alloys
Detroit, Michigan

Industrial Heating
March - April 1979

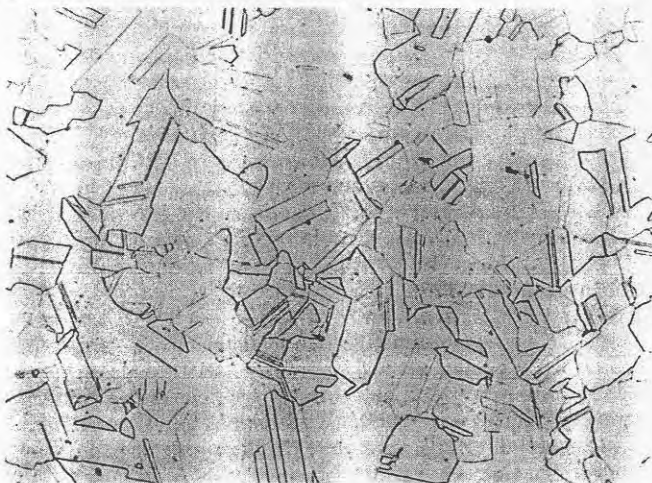
Fig. 1 Mill annealed RA-330 with resultant grain size of about ASTM 5. Etchant: Mixed acids — 25 parts HCl, 19 parts alcohol and 7 parts HNO₃. Magnification 100X (enlarged 20%).

In addition to chemistry, the properties of any metal are related to microstructure. Fig. 1 illustrates an example of annealed RA-330, with a few scattered carbides in a matrix of about ASTM 5 grain size. Numerous annealing twins are present. This microstructure, with the exception of grain size, is typical of a wide range of alloys from common stainless up through the nickel alloys. RA-333, a higher alloy material, exhibits a larger volume of dispersed carbides, as illustrated in Fig. 2. The grain size of this sample is also about ASTM 5.

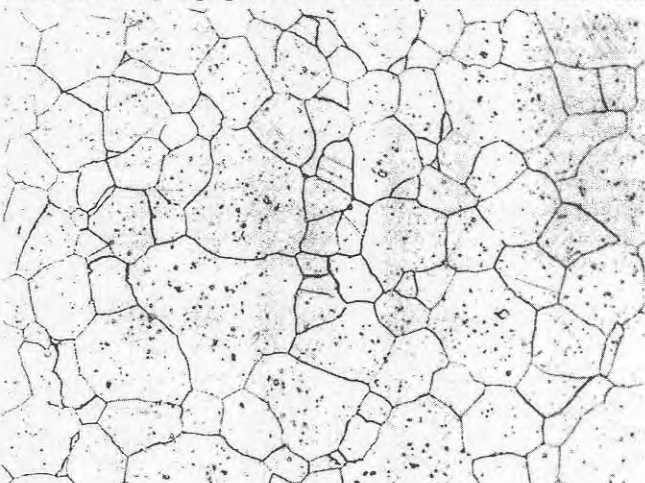
Fig. 2 Mill annealed RA-333 with resultant grain size of about ASTM 5 exhibits higher volume of carbides than RA-330 because of higher degree of alloying elements. Etchant: Mixed acids. Magnification 100X (enlarged 20%).

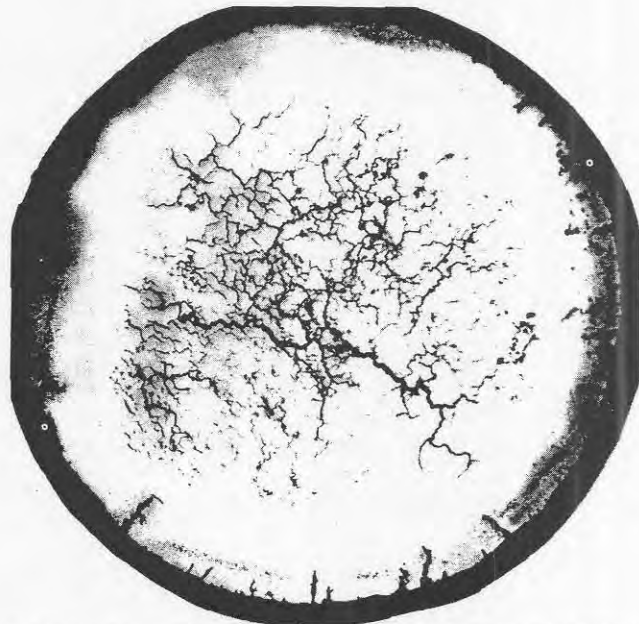
Fig. 3 Internal thermal fatigue cracks in cross section of $\frac{1}{2}$ " diameter RA-330 bar frame basket.

Figs. 3-6 illustrate the combined effects of bar diameter and grain size upon thermal fatigue and carburization. The samples are from a $\frac{3}{8}$ " diameter bar frame basket, lined with wire mesh and having $\frac{1}{2}$ " diameter bars mounted horizontally above the frame work for handling. Material was a 35Ni-18Cr-1.5Si alloy similar to RA330, but not supplied by Rolled Alloys.

Metallography revealed that the $\frac{1}{2}$ " diameter bar was a maze of internal intergranular thermal fatigue cracks (Fig. 3) and, in addition, was rather carburized (Fig. 4). The chromium carbides form a semi-continuous network on grain and twin boundaries as well as being distributed throughout the matrix. Thermal fatigue cracks follow the grain and carbide-matrix boundaries. These crack surfaces and, to some extent, the carbides subsequently oxidized. Grain size of this $\frac{1}{2}$ " diameter bar is about ASTM 2-4, somewhat coarser than optimum for bar frame baskets.

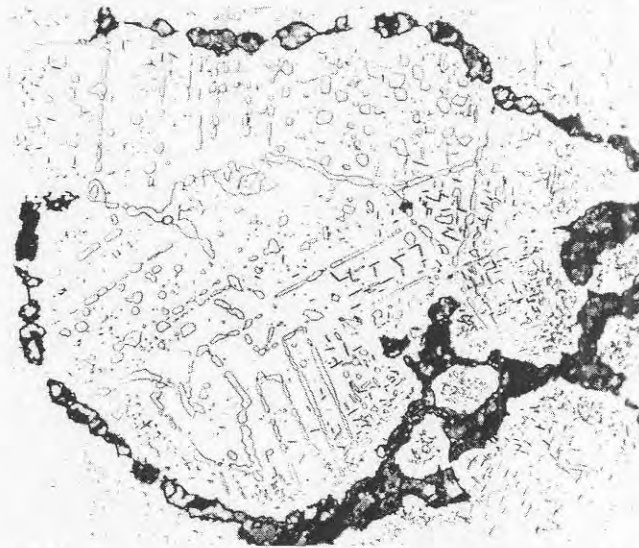
Fig. 4 Microstructure of sample shown in Fig. 3 evidences semi-continuous network of chromium carbides on grain and twin boundaries as well as being distributed in the matrix. Etchant: Mixed acids. Magnification 500X (reduced 5%).

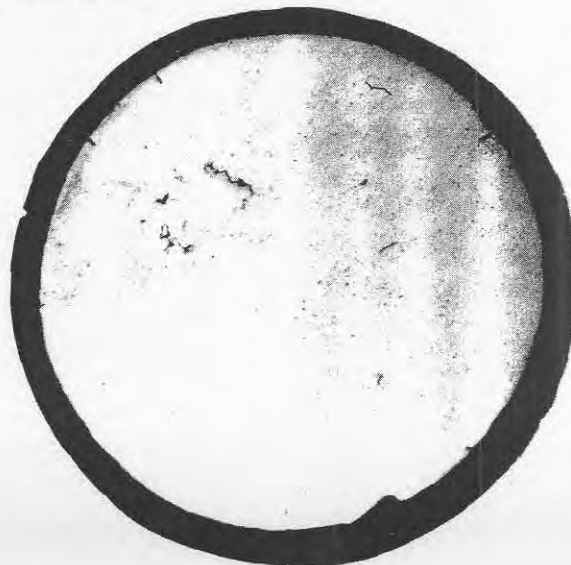
Fig. 5 Little internal damage is evident in cross section of $\frac{3}{8}$ " diameter RA-330 bar frame basket.

The $\frac{3}{8}$ " diameter bar, having some 44% less cross-sectional area than the $\frac{1}{2}$ " bar, was able to heat and cool more uniformly throughout its section, hence suffered less thermal strain during each heat treat cycle. As a result, these smaller bars showed little internal damage or internal carburization (Figs. 5 and 6). This is a striking illustration of the relationship between section thickness and service life in liquid quenching applications.

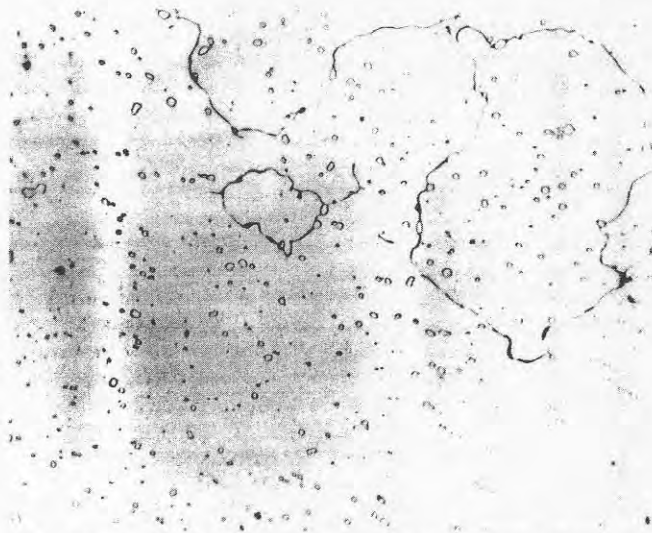
Fig. 6 Microstructure of sample shown in Fig. 5 shows little internal carburization. Etchant: Mixed acids. Magnification 500X (reduced 5%).

The ASTM 5 or finer grain size of the $\frac{3}{8}$ " bar, which must have had a positive influence, would be considered quite acceptable for heat treating service.

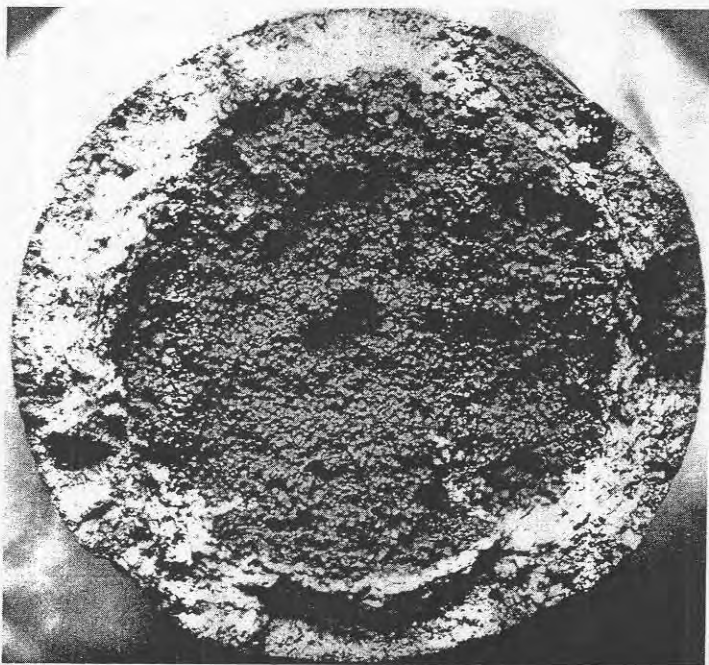
Fig. 7 Fracture surface of ½" diameter RA-330 bar frame basket.

Internal thermal fatigue is the normal (but not well recognized) failure mode for those bar baskets or fixtures used primarily for through hardening of carbon or alloy steels. Failure manifests itself by sudden breakage in service or during straightening with no evidence of ductility. The cracks grow both longitudinally and transversely. A branched longitudinal crack may run down the center of the bar, much like an internal forging burst. It would seem that this crack should grow and split the entire bar lengthwise, but before it does so a series of evenly spaced transverse cracks usually grow to fracture. These internal thermal fatigue cracks, shown as a maze of intergranular cracks in Fig. 3, appear to begin near the center of the bar and grow outward until only a thin rim of sound metal remains. A room temperature transverse fracture of such a bar reveals a rough, blackened area in the center surrounded by a rim of bright metal (Fig. 7) representing the sound portion of the metal.

The only outward sign that such failure is about to occur is a series of circumferential contractions or "rings" spaced periodically along the bar. Each such contraction represents a plane where internal fatigue cracks have nearly reached the surface. Sighting along the bar at a light source is the easiest way to see these rings. The bar may be readily broken at each such ring and will reveal a fracture surface similar to that shown in Fig. 7.

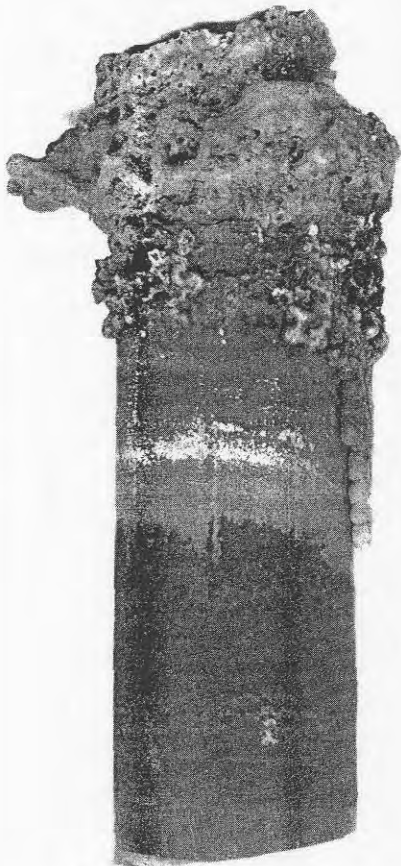
Fig. 8 Destruction of vertical alloy radiant tube due to sooting and melting upon carbon burn-out.

Increasing carbon content also lowers the melting point of an alloy. A combination of high local temperatures and high carbon occasionally results in some component melting. Radiant tubes are most prone to melting during carbon burn-out. The furnace thermocouple may read only 1700°F or so but burning soot deposits can raise the temperature in some areas of a radiant tube to the point that it carburizes severely and begins to melt. Once melting begins, carburization is more rapid and a whole section of the tube may melt catastrophically. Fig. 8 illustrates a vertical alloy radiant tube which excessively vigorous soot burn-out has destroyed.

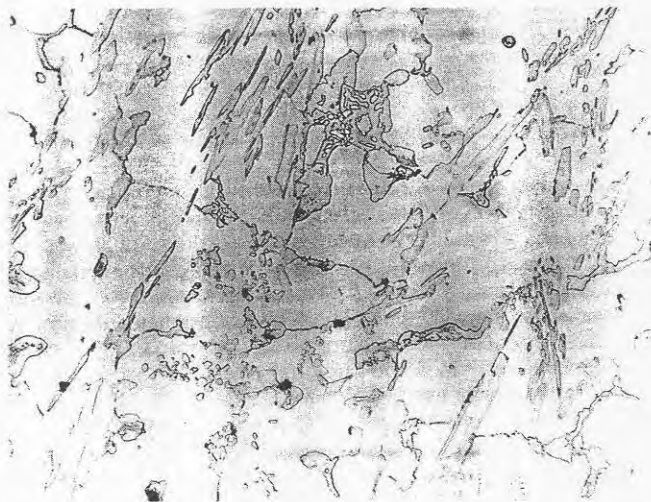
Fig. 9 Silver brazing alloy reaction with furnace muffle made of RA 330 (35% Ni, 19% Cr, 1.25% Si) formed low melting-point compounds through two-thirds of the muffle wall thickness. Etchant: mixed acids. Magnification 100x (reduced 25%).

atmospheres are reducing to chromium, and the heat resistant alloy muffle will remain bright and clean inside. Under these conditions it takes little copper or silver braze to wet and penetrate or crack the austenitic alloy. For example, an RA-330 muffle was used for silver brazing at 1600°F under hydrogen atmosphere. The muffle interior was visibly bright and clean with a large amount of silver braze spilled over the bottom. Reaction of this braze alloy with the muffle formed the detrimental compounds shown in the photomicrograph, Fig. 9. The reaction proceeded from the inner surface through about two-thirds of the wall thickness.
