## **RA333 Flare Tip in Use at a Midwestern Oil Refinery Completes its 3-1/2 Year Tour of Duty and is Readied for a Second**

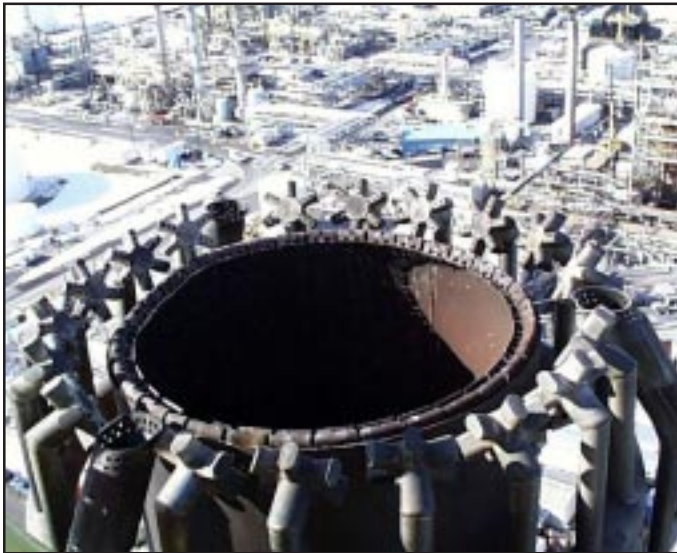
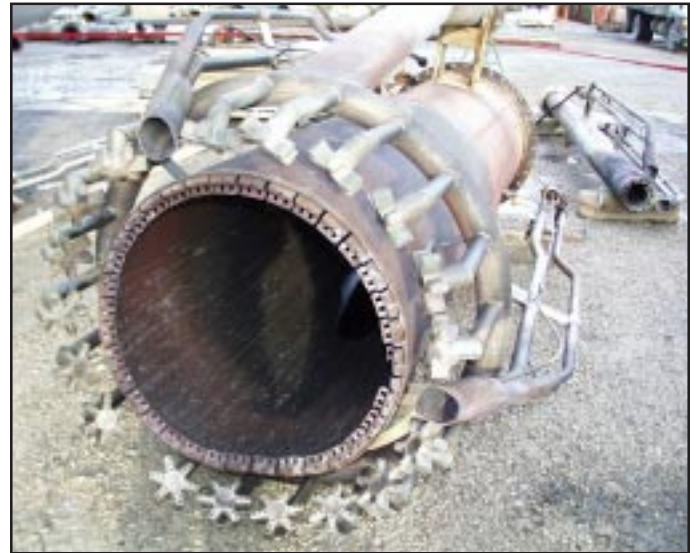
The second RA333 tip, installed October 1995 was taken down during a shutdown in March 1999. After 3 1/2 years service, the RA333 portion (shown above) was like new. The only items requiring repair were those portions still made of 310 or HK castings such as steam nozzles and the pilot flares. Once these repairs are completed the flare will be kept on hand as a spare and will be installed during the next scheduled shutdown.

The flare tips here consist of a 66 inch long cylinder of 3/8 inch thick RA333 plate at the top, (1676 mm long, 9.5 mm plate) butt welded to a like cylinder of carbon steel. The stack itself is a 30" diameter pipe, 237 feet tall from base to top (762 mm diameter, 72 m tall). Maximum capacity is 640,000 pounds per hour (290,000 kg/hr) of waste gas. To get a "Smokeless Flame" steam injection is used to increase combustion of the hydrocarbons. Flare tips are subjected to flame impingement on the outside, low flow conditions, and/or internal burning. Strong winds can blow the flame onto the flame retention rings, and on the outside. If the old refractory lining failed, air infiltration could cause internal burning to the point where the tip was seen to glow red.
